Swing-Flex® Check Valve Proof of Performance Test Report

Val-Matic Swing Flex® Check Valve Size 6", Model 506 with ANSI 125 LB. Flanges, Cast Iron Body and Cover, Nylon and Steel Reinforced Buna-N Disc.

Observation of Performance Tests

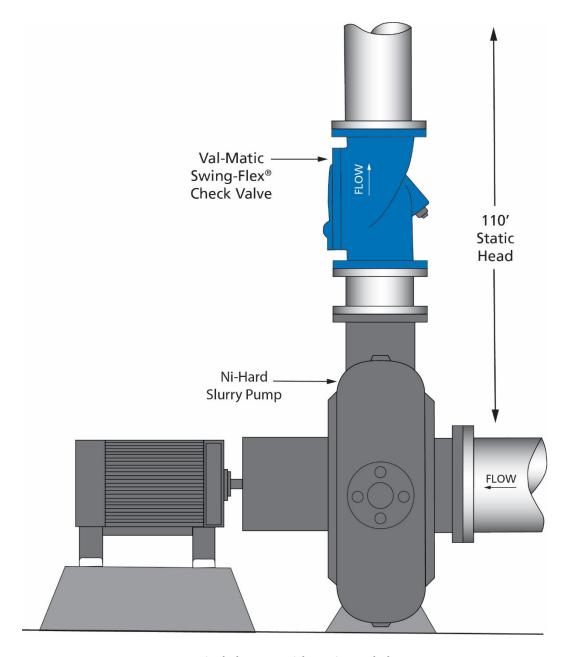
The valve was installed in a coal burning, 220 MWT power station, in a bottom ash recovery system. The system has been in service for 15 years. Flow conditions through the valve are as follows: The valve is mounted in a vertical flow up position just off an 800 GPM Ni-Hard horizontal slurry pump (Figure 1). Head is 110 feet, temperature varies from 110°-130° Fahrenheit. The media is light bottom ash suspended in recovery water. It is extremely aggressive, as it is not only very abrasive, but also corrosive due to the acidic nature of the water. The system is typically in service 24 hours a day and cycles approximately 30 times a day.

FIGURE 1. Vertical Flow Up with Horizontal Slurry Pump

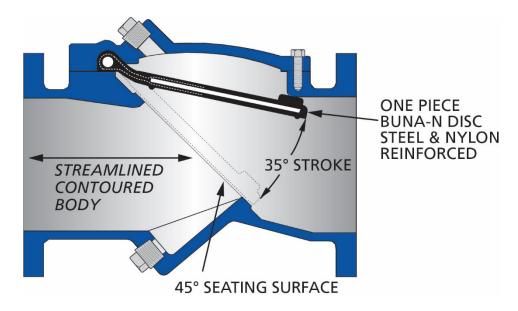
In October of 1987 the user decided to try a Val-Matic Swing Flex type check valve (Figure 2).

FIGURE 2. Swing-Flex® Check Valve
