**Swing Flex<sup>®</sup> Check Valve  
Proof of Performance  
Test Report**

Val-Matic Swing Flex® Check Valve  
Size 6", Model 506 with ANSI 125 LB. Flanges,  
Cast Iron Body and Cover, Nylon and Steel  
Reinforced Buna-N Disc.

### **Observation of Performance Tests**

**PSI No:** 150-38027-001

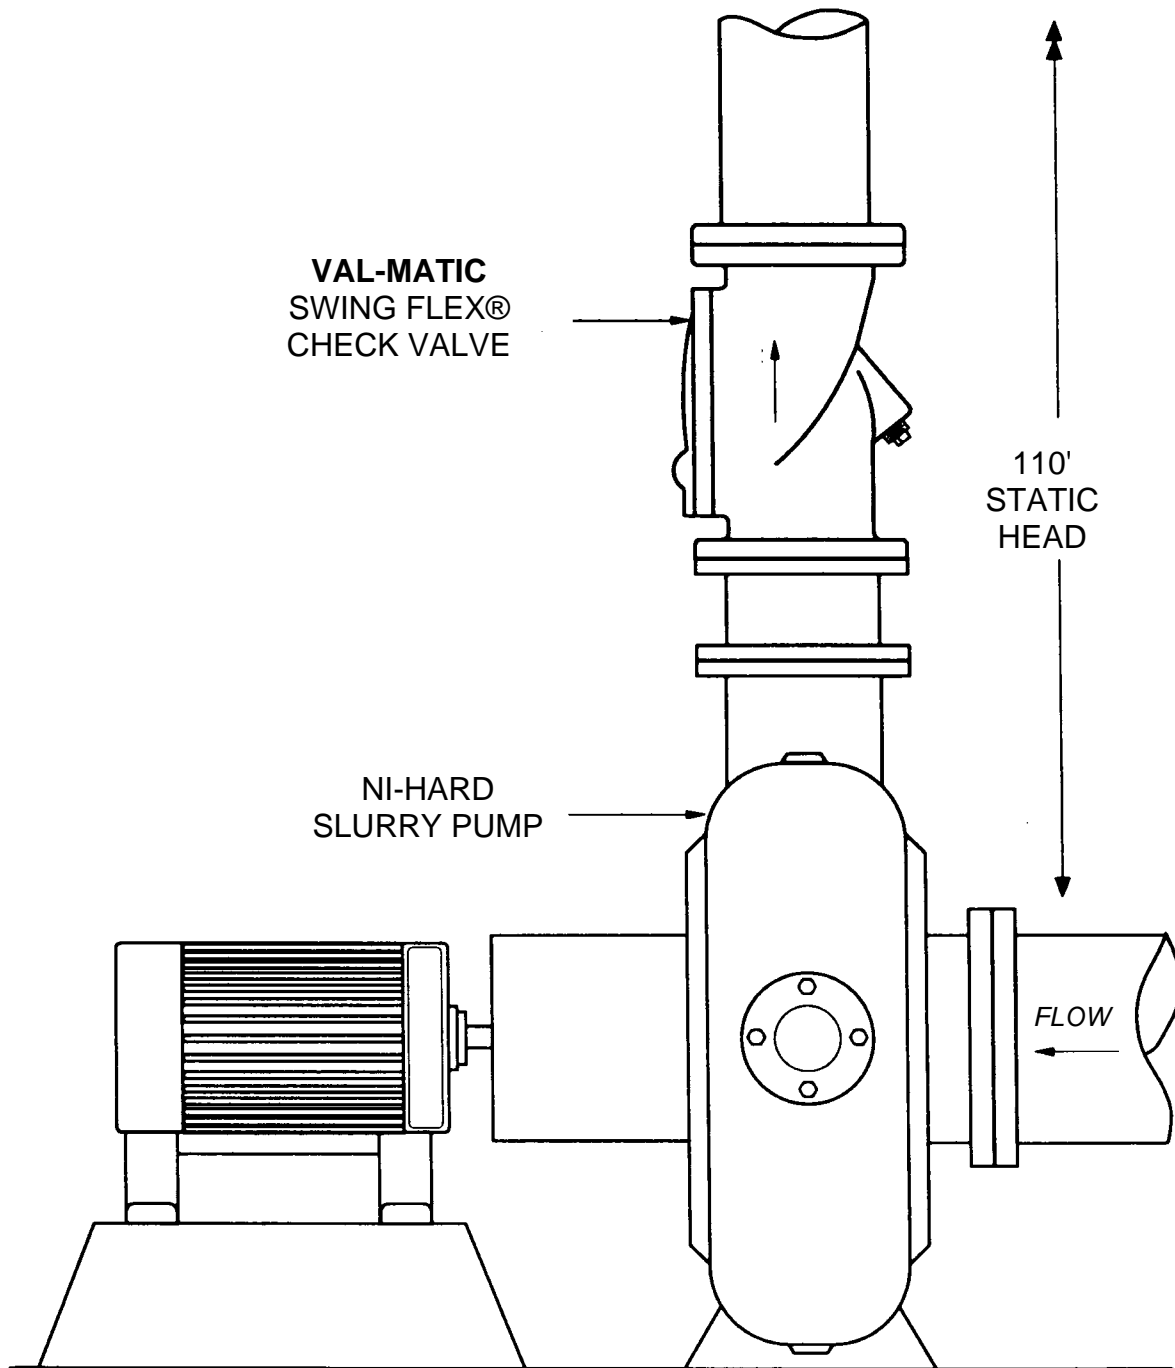
Figure One

The valve was installed in a coal burning, 220 MWT power station, in a bottom ash recovery system. The system has been in service for 15 years. Flow conditions through the valve are as follows: The valve is mounted in a vertical flow up position just off an 800 GPM Ni-Hard horizontal slurry pump (Figure One). Head is 110 feet, temperature varies from 110°-130° Fahrenheit. The media is light bottom ash suspended in recovery water. It is extremely aggressive, as it is not only very abrasive, but also corrosive due to the acidic nature of the water. The system is typically in service 24 hours a day and cycles approximately 30 times a day.

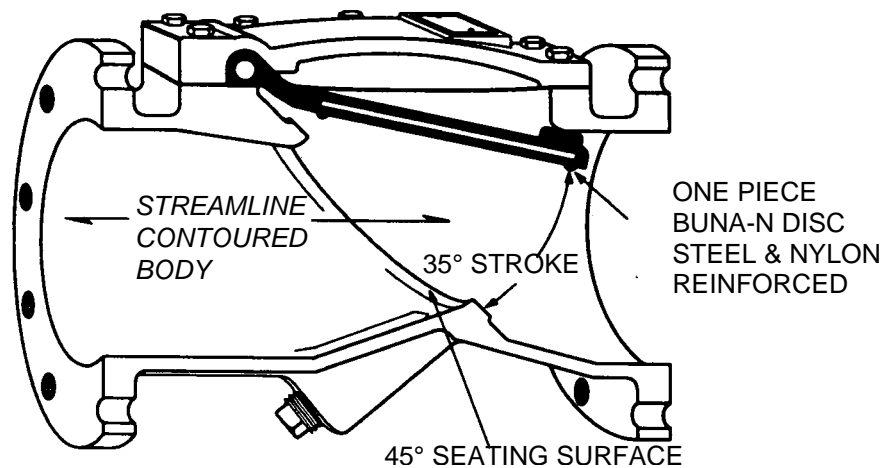
**Figure Two**

The Swing Flex utilizes a one piece steel and nylon reinforced Buna-N rubber disc. The seat is on a 45° angle minimizing disc travel and therefore minimizing slamming. The cast iron body is streamlined and contoured to allow for smooth, non-turbulent flow through the valve.
