## Downsurge Eliminated

Rachel Hartman

Val-Matic Valve & Mfg. Corp.

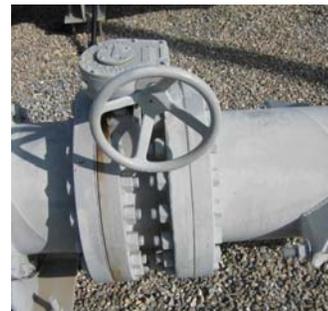
In 2008, Steve Crump of Crump Co., a Val-Matic Valve & Mfg. Corp. Representative, encountered problems at The Kern-Tulare Water District in Bakersfield, California. The Water District was experiencing a slamming tilted-disc check valve with a leaking oil dashpot and butterfly valve with a leaky seat. A Val-Matic competitor's tilting-disc check valve consistently slammed at pump start up and its top mounted dashpot was leaking oil. Around the same time, a different competitor's Butterfly Valve seat began leaking.

**Failed Butterfly Valve**

The original Butterfly valve was replaced by the Val-Matic American-BFV® Butterfly valve which eliminated the leakage. Val-Matic's Butterfly valve features the Tri-Loc system, which allows for easy seat adjustment and or replacement using only a socket wrench - no hypodermic needles or epoxies required. Val-Matic Valve & Mfg. Corp.'s product line keeps your applications running smoothly by offering superior valves at an affordable price.

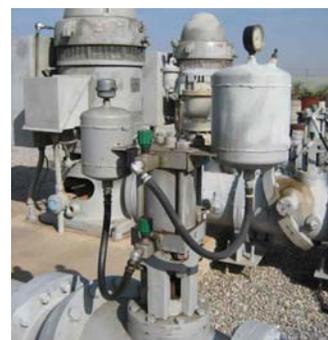
**Leaking Dashpot**

Val-Matic replaced the slamming hydraulic-assisted tilting-disc check valve with the Surgebuster® HD. The Surgebuster® HD is Val-Matic's swing check valve with only 2 moving parts – a disc and spring which close the valve disc rapidly thus minimizing slamming. After cycling the pumps, the owners were pleased with the lack of slamming the Surgebuster® provided and the elimination of the leaking oil dashpot.

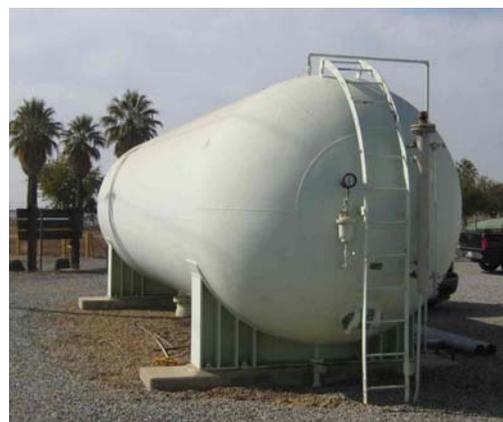
Dan Antonini, the General Superintendent of the Kern-Tulare Water District explained how the system operates: the pumps lift water from a pond about 10 feet high into a 4-mile-long 36" pipeline at 110 psig and 16,000 gallons per minute (gpm) with three pumps running. The flow through the valves is 5,500 gpm (8.78 feet per second). In addition, there is a massive 8 feet diameter by 30 feet long hydropneumatic surge tank with two 24" pipe connections to the header; this is designed to prevent column separation and absorb surges.

**Hydropneumatic Surge Tank**

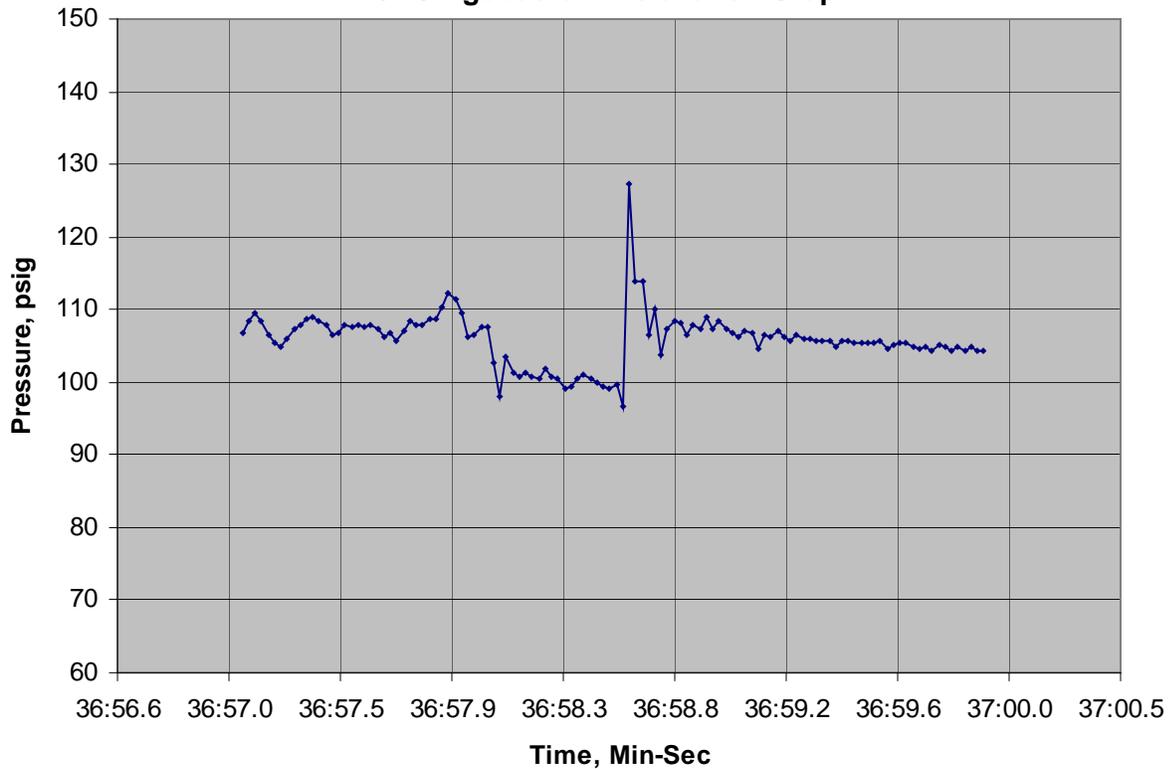
## 16" Surgebuster® Installation Graph

The data from the transducer from both before and after the Surgebuster<sup>®</sup> was installed, was exported into a spreadsheet and a 3-second time period was graphed. In both cases, the pumping pressure before the trip was about 108 psig indicating that the valve was fully open. In both tests, the flow reversal time was about 0.50 sec., which translates into a deceleration of 8.78/0.50 or 18 ft/sec<sup>2</sup>. Before installing the Surgebuster<sup>®</sup>, the valve allowed significant flow reversal, which caused a downsurge to 65 psig and water discharge from the air valve and a pressure rise to 119 psig. After the installation (see 16" Surgebuster<sup>®</sup> Installation Graph below), the downsurge was eliminated and the pressure rose to an acceptable 127 psig.

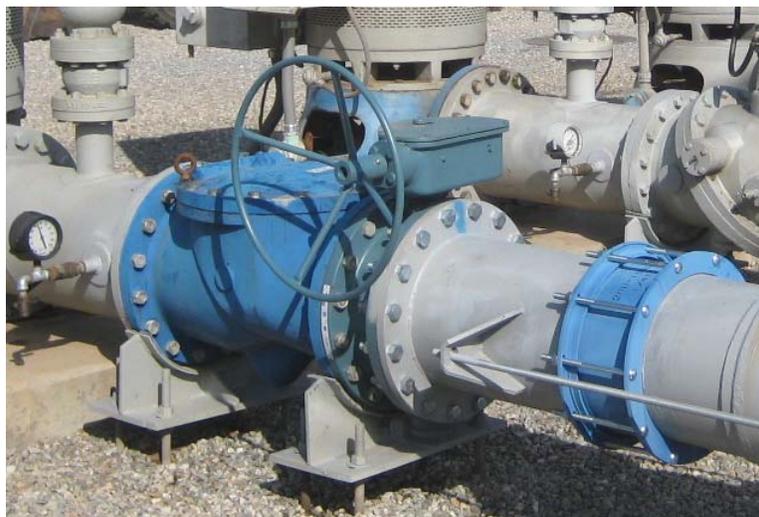
**Val-Matic Surgebuster® HD and  
Val-Matic American-BFV® Butterfly Valve installed**
